AGENDA

ITEM	AMSC2
	ASSET MANAGEMENT SUB COMMITTEE
DATE	10 June 2025
HEADING	Sir Douglas Mawson Lake - Lake Infrastructure
AUTHOR	Dulan Gamage, City Infrastructure Engineer, City Infrastructure
CITY PLAN LINKS	<p>1.2 The health and wellbeing of our community is a priority</p> <p>2.3 Our community, environment and infrastructure are adaptive to a changing climate</p> <p>4.2 We deliver quality outcomes that meet the needs of our community</p>
SUMMARY	<p>This report provides an update on the structural condition, ongoing monitoring, remediation, and maintenance of the lake edge revetment walls supporting the perimeter pathways at Sir Douglas Mawson Lake (SDML). Constructed approximately 25 years ago, these walls have experienced erosion of the lake bed at the toe of the wall, structural cracking and wall movements affecting paving requiring ongoing pavement repairs and preventative maintenance.</p> <p>This report outlines:</p> <ul style="list-style-type: none"> • Description of the design and construction of the walls • Current monitoring and condition assessments of the lake edge walls. • Remediation works completed to date and future requirements. • Recommendations for future monito

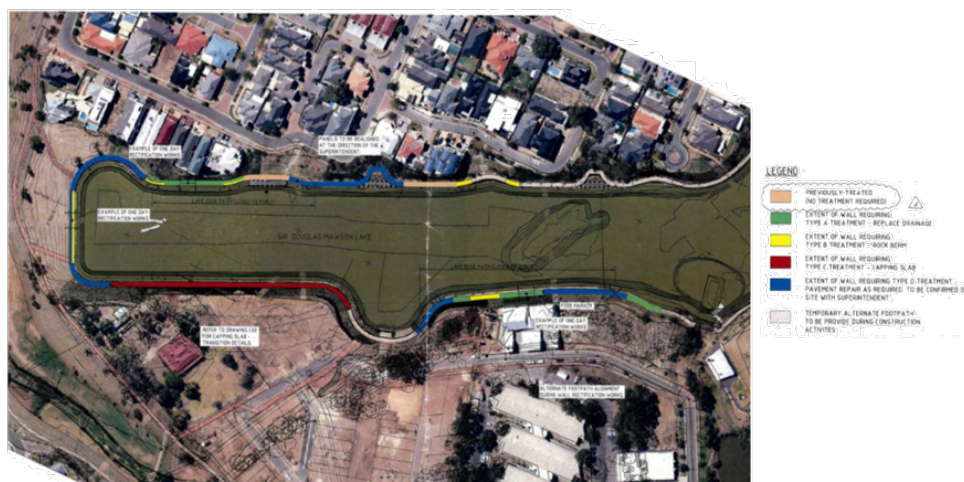
Figure 4- WGA Lake Edge Wall Rectification Areas (WGA, 2005)

- KBR proposed a tieback solution (see Figure 3) around the time of handover of Mawson Lakes to Council for ongoing care and maintenance.
 - WGA investigated sections of failing revetment walls within Stage 2 of SDML. They recommended using 600mm wide x 2000mm long grout-filled plastic bags to fill voids and reinforce walls stability. There were four wall rectification strategies (Type A to D), tailored to different segments of the wall (See Figure 4 and Figure 5 – *WGA Rectification Areas and Treatment Details*).

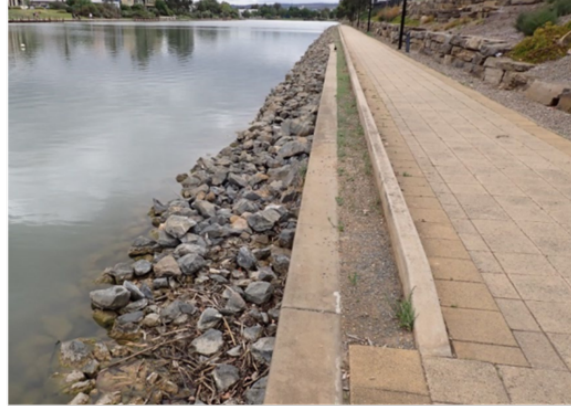
Figure 8- Delfin Lendlease Repair Works with Upright Kerbing

placement of rock fill against the edge walls. The repair also included an upright concrete kerb as shown in Figure 8. Observations of this section of lake indicate that further structural remediation in this location is not required, although in future years, the aesthetic surrounding this section could be improved through additional rock placement to cover the lake edge where still exposed. Some semi-aquatic planting amongst the rocks could also be considered to enhance appearance and biodiversity. However, these works are a low priority and it is currently unfunded.

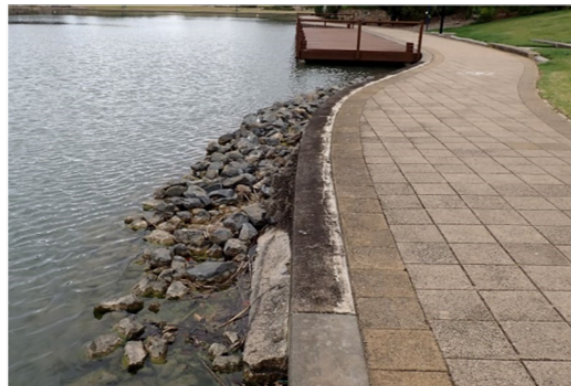
Figure 9- Delfin Lendlease Repair Works

- 1.10 Delfin Lendlease had also undertaken repair works for a small section of wall located on the opposite (southeastern) end of the lake. A significant wall failure had occurred at this location at the convex bend. The repair method can be seen in Figure 9. At this stage, no immediate or further remediation works is required for this location.

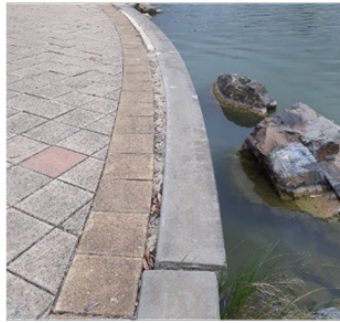
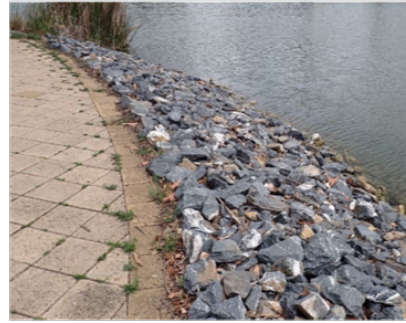
Figure 10- Section 14 Edge Wall Remediation Works (Before & After)

- 1.11 Repairs for Section 14 and 15 of the revetment walls were undertaken by Council in 2023 and involved the placement of rock riprap (typically between 100-250 mm diameter) along the edge wall. Figure 10 and Figure 11 illustrates the condition of the lake edge wall prior to and following remediation works:

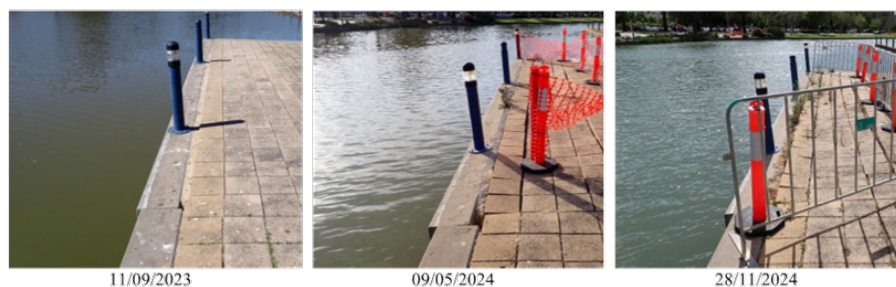
Figure 12- Progression of Section 4 Wall Toppling Failure

- This section exhibited significant erosion at the toe as discovered during wall reinstatement, explaining the large (~100mm) outward rotation (toppling) of about 12 m length of wall at this location.
- Figure 12 shows progression of wall and paving failure with time.
- \$60k of funding was provided via the 2024/2025 First Quarter Budget Review in November 2024.
- Remediation works commenced in early December 2024 and were completed on 19 Dec.

1.13 Section 5 (further east of Section 4) is currently showing early signs of movement, warranting preemptive action.

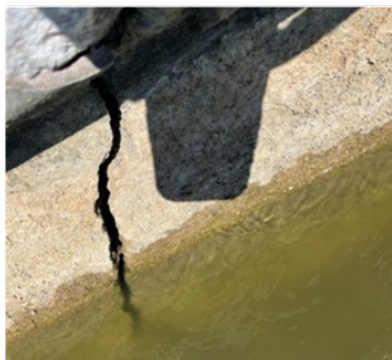
Figure 13- Cracks observed along upper perimeter of lake edge wall

It was initially suspected that leakage may be occurring around the upper perimeter of the lake, potentially through cracks and other structural defects in the edge wall, such as the one shown in Figure 13 below.

However, a review of the lake wall construction drawings (refer to detail below) indicates that the edge wall includes a Nylex 200 strip drain with 80 mm diameter UPVC weep holes spaced at 5 m intervals. This design allows any water seeping through the wall to be redirected back into the lake, minimising the risk of water loss through the wall structure itself.

In addition, if significant seepage were occurring through the wall, surface heaving or pavement level changes would typically be expected as a visible symptom. In the absence of such signs, it is more likely that any substantial water losses are due to compromise or degradation of the bottom liner, rather than through the wall.

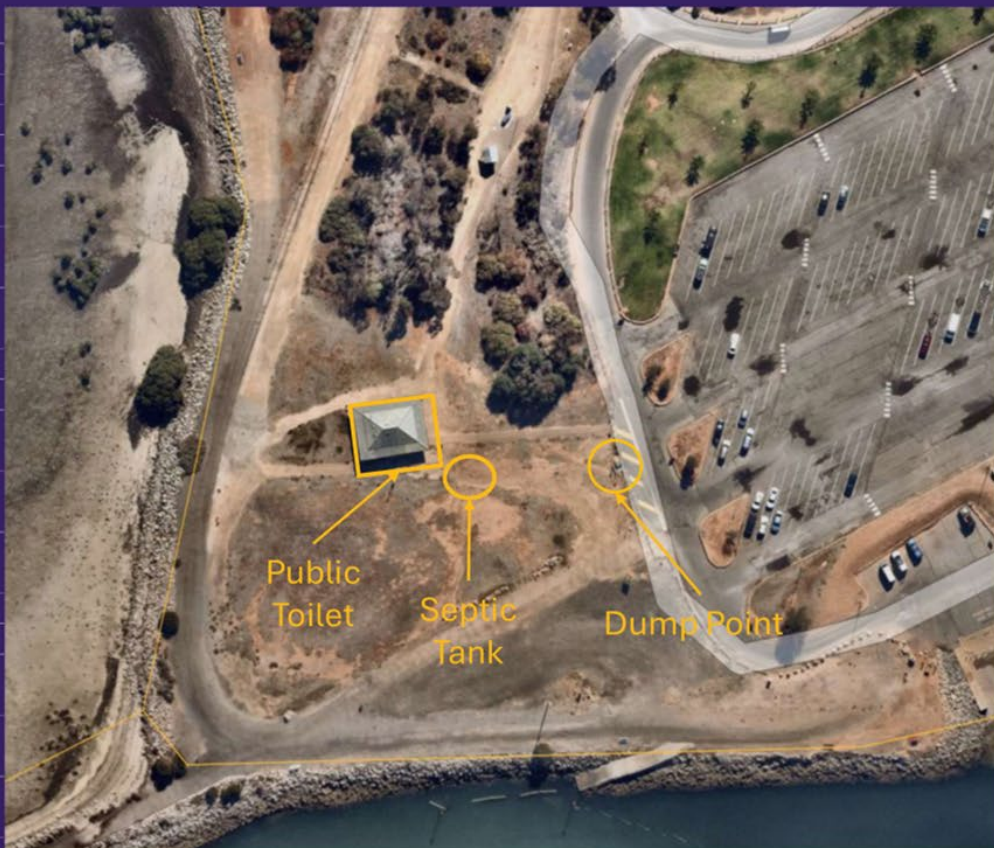
- St Kilda is currently unsewered with the closest sewer point being 4.5km away.
- Council installed a RV dump point at this location 2012.
- The RV dump point is connected to a septic tank that services the public toilets
- The RV dump point has been out of service since October 2024 due to multiple breaks in the pipe connecting the dump point to the septic tank.
- Because the asset was constructed in a landfill, land subsidence is expected issue that will potentially damage built infrastructure.

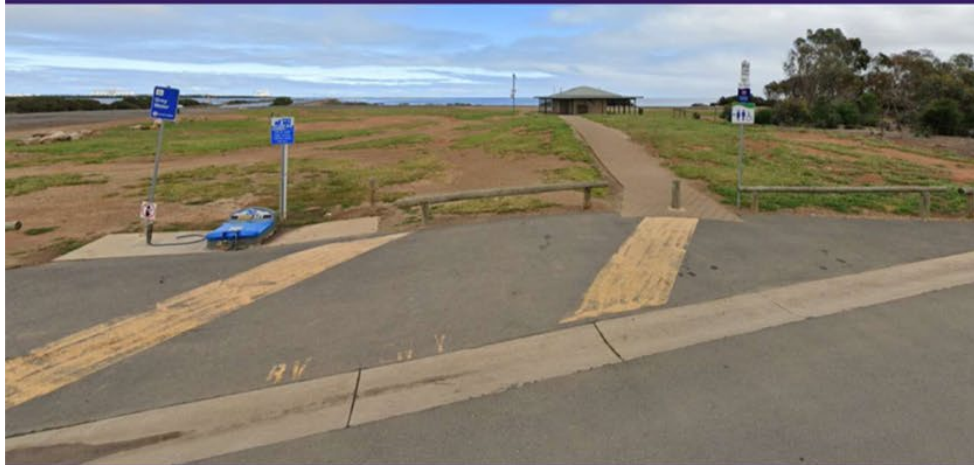
- The work required to reinstate the dump point includes:
 - Reconstructing the dump point.
 - Relaying the pipework from the dump point to the septic tank.
- As the work constitutes modification to the septic tank, approval from the relevant authority is required (SA Health).
- SA Health has informed Administration under the current legislation and code of practice, the discharge of RV wastewater into septic tanks is prohibited.
- As such, Administration are unable to reinstate like for like.
