Native Grasses Forum 2016

Shaun Kennedy
Specialist - Vegetation Services
SA Water

***Native Grasses
~ for ~
Restoration Hipsters***

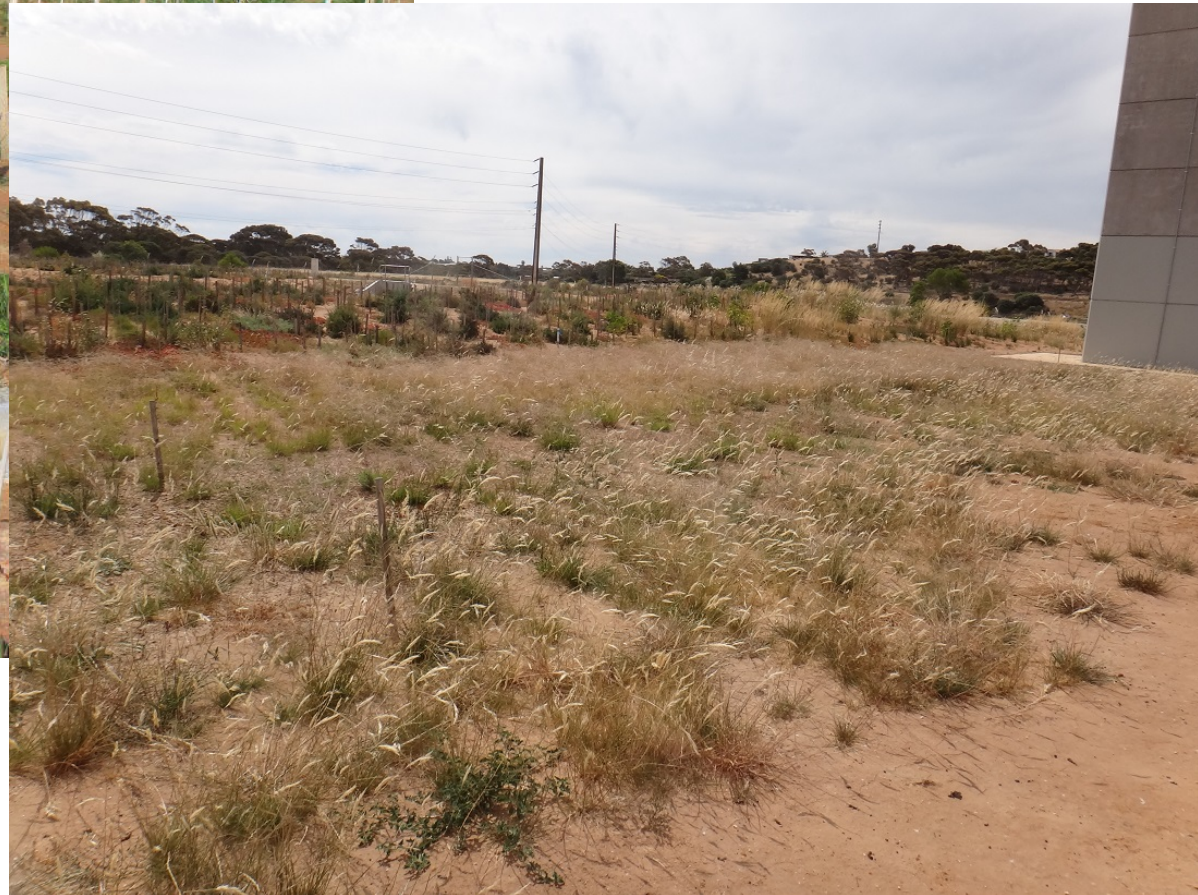
Noarlunga Downs Wetland – erosion control

Noarlunga Downs Wetland – erosion control

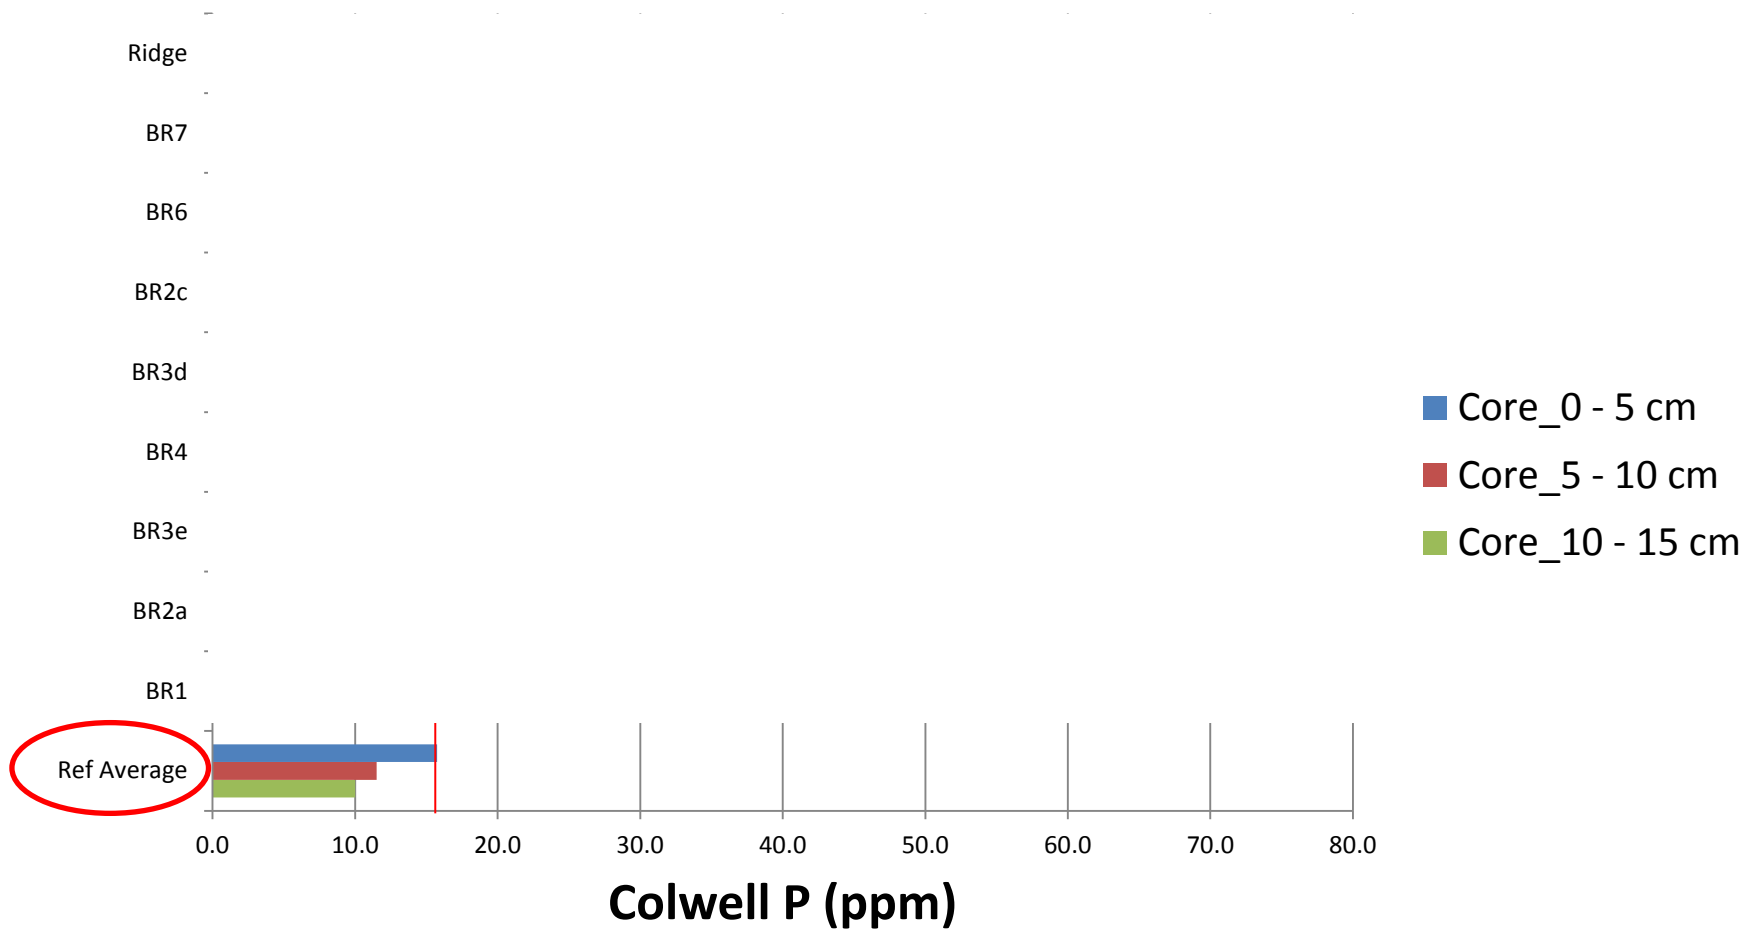
Nutrient analysis - Kangarilla

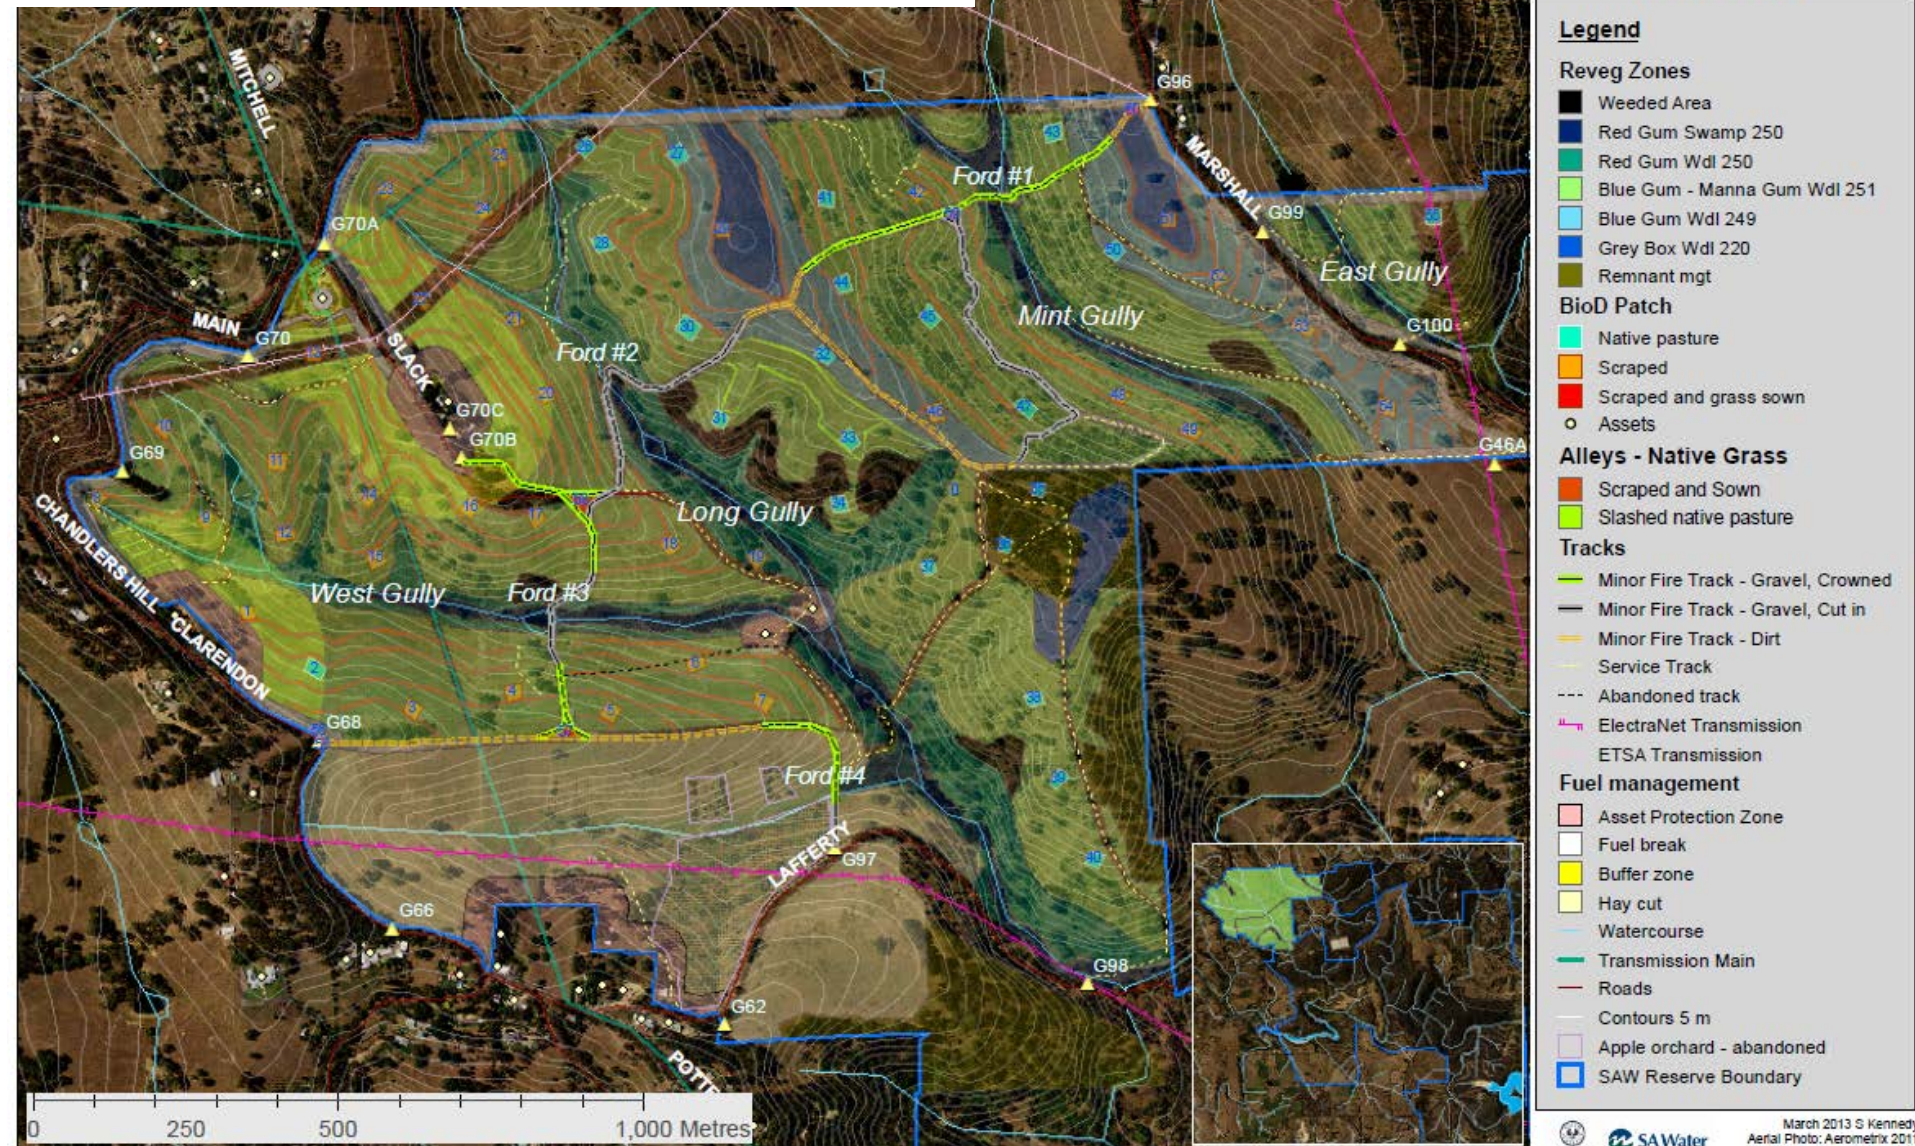
CLARENDON CARBON BIOSEQUESTRATION - WORK ZONES -

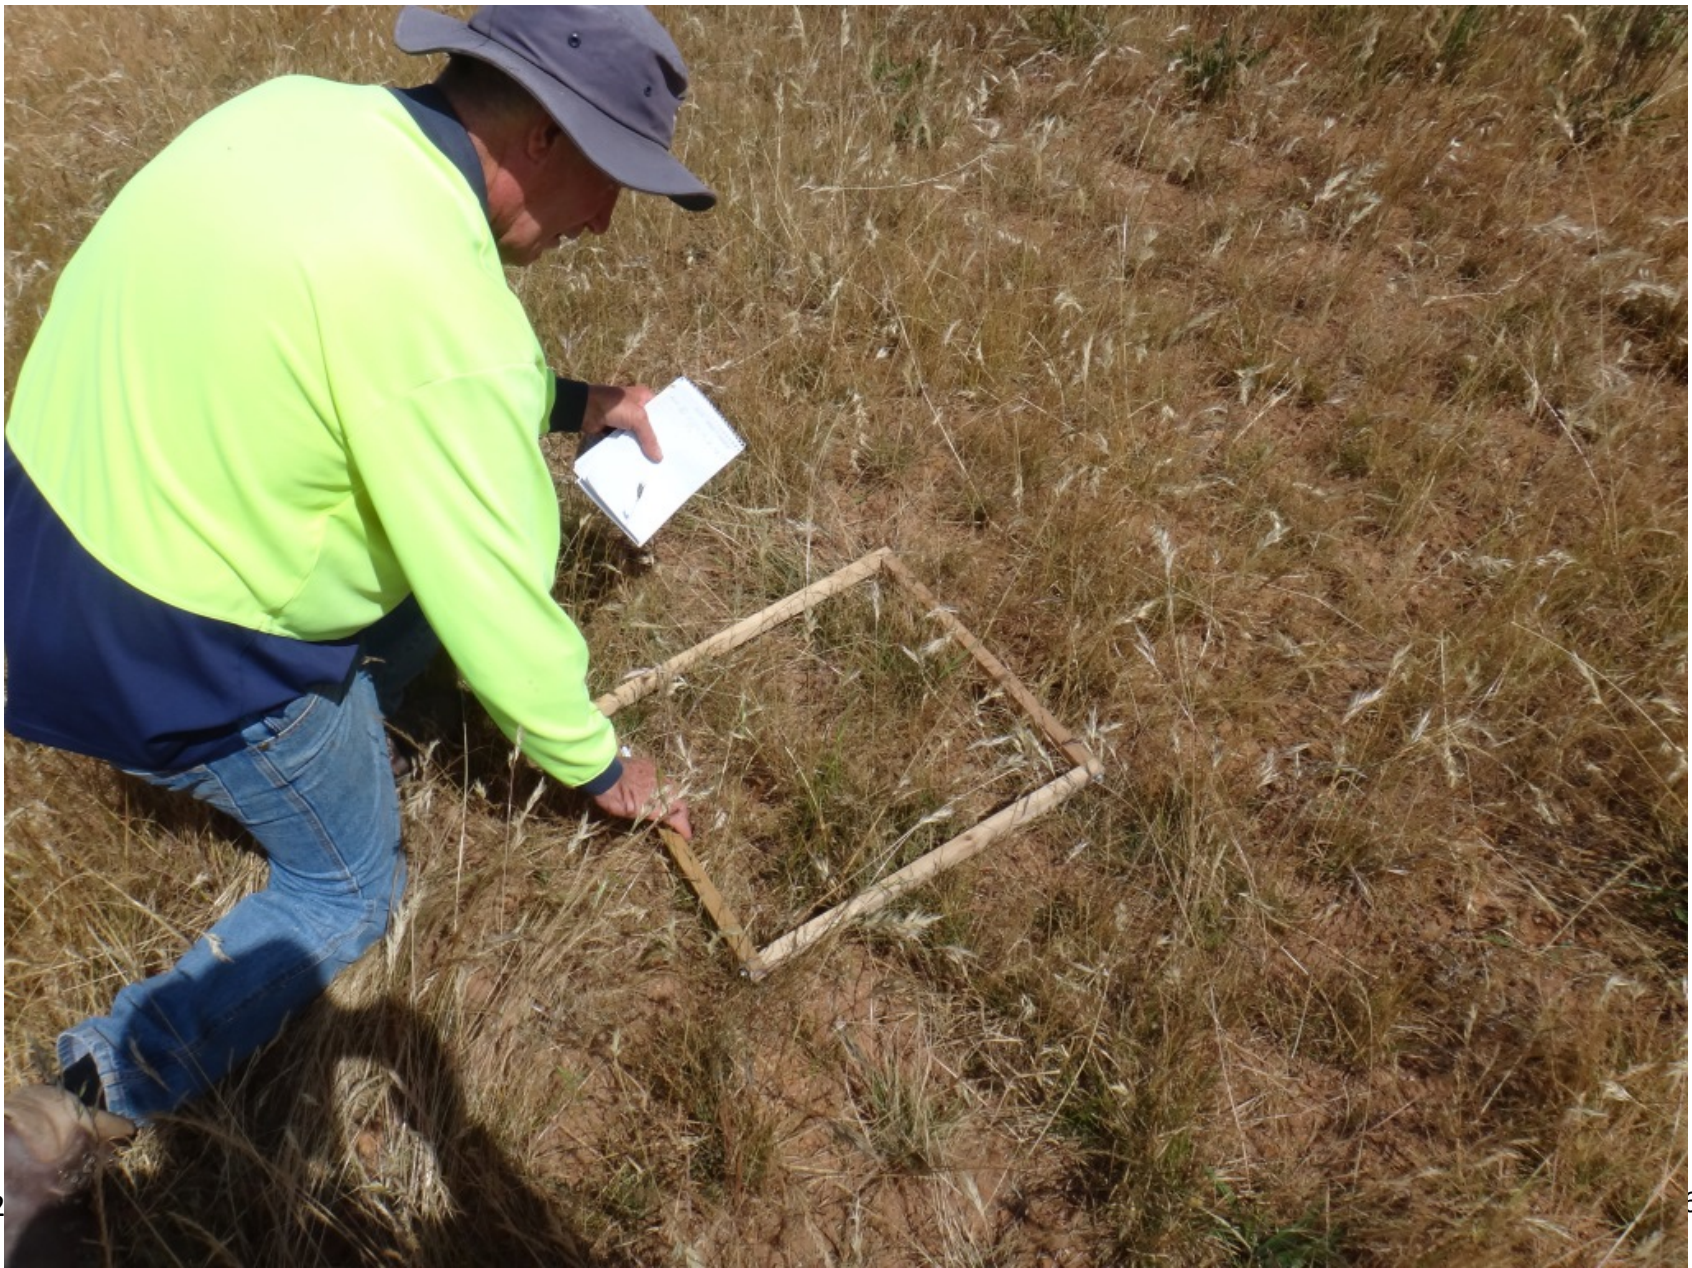
Clarendon – establishment counts

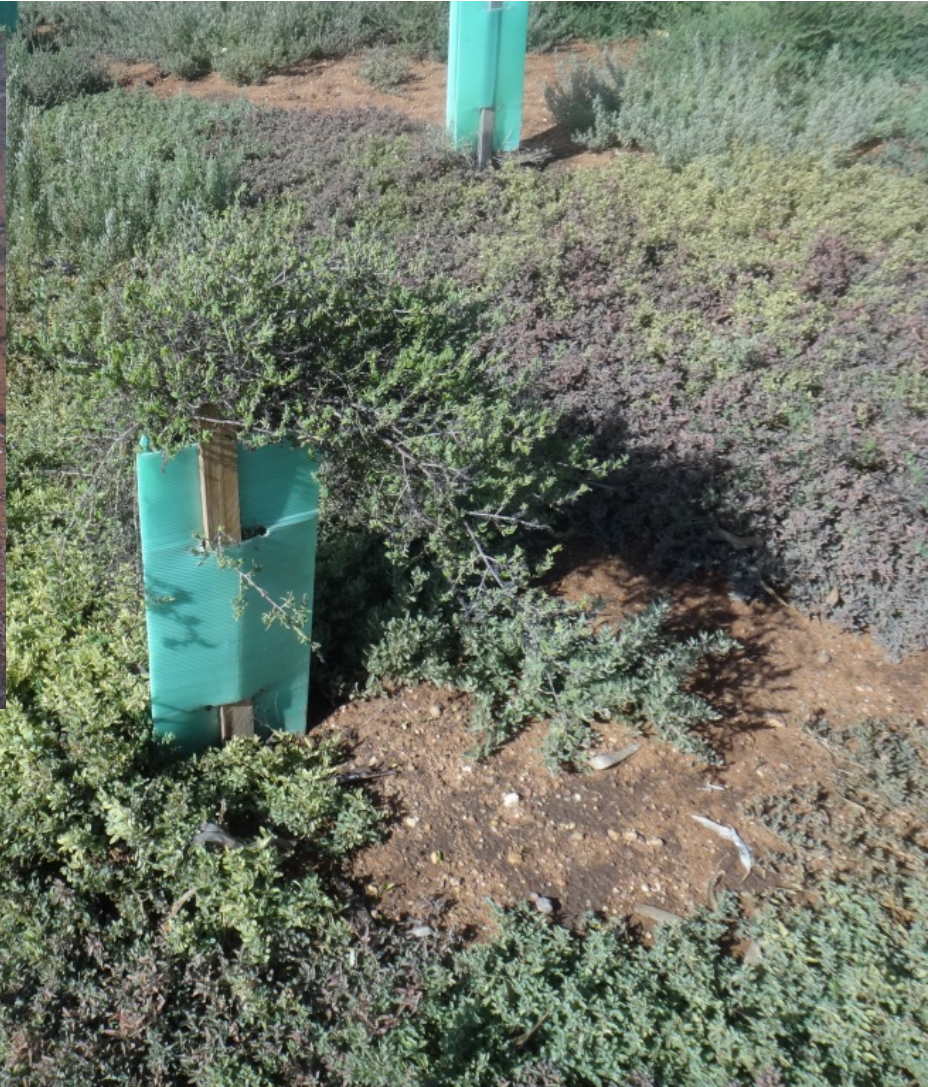
Murray Bridge East (Tubestock VS Seed)

Tubestock vs Seeding

Grassland Zone 2.5 ha

- Sow rate 29 kg/ha (floret)
 - *D. cespitosa*, *D. setacea*, *Stipa nodosa*, *S. scabra* *Ennaepogon*, *Chloris tuncata*

Density result = average 66 pl/m²

Across 2.5 ha = 1,650,000 ng seedlings

- Chenopod sow rate 17.5 kg/ha

Density result = 1 pl/m² or 10,000 /ha

- So we're talking 250,000 chenopods

Total = 1.85 million plants

- Seed \$12k
- Labour \$20k
- \$32 k 3ha = \$10.6 k/ha
- Works out around \$0.01 / plant
