AGENDA

ITEM	AMSC2
	ASSET MANAGEMENT SUB COMMITTEE
DATE	10 June 2025
HEADING	Sir Douglas Mawson Lake - Lake Infrastructure
AUTHOR	Dulan Gamage, City Infrastructure Engineer, City Infrastructure
CITY PLAN LINKS	<p>1.2 The health and wellbeing of our community is a priority</p> <p>2.3 Our community, environment and infrastructure are adaptive to a changing climate</p> <p>4.2 We deliver quality outcomes that meet the needs of our community</p>
SUMMARY	<p>This report provides an update on the structural condition, ongoing monitoring, remediation, and maintenance of the lake edge revetment walls supporting the perimeter pathways at Sir Douglas Mawson Lake (SDML). Constructed approximately 25 years ago, these walls have experienced erosion of the lake bed at the toe of the wall, structural cracking and wall movements affecting paving requiring ongoing pavement repairs and preventative maintenance.</p> <p>This report outlines:</p> <ul style="list-style-type: none"> • Description of the design and construction of the walls • Current monitoring and condition assessments of the lake edge walls. • Remediation works completed to date and future requirements. • Recommendations for future monito

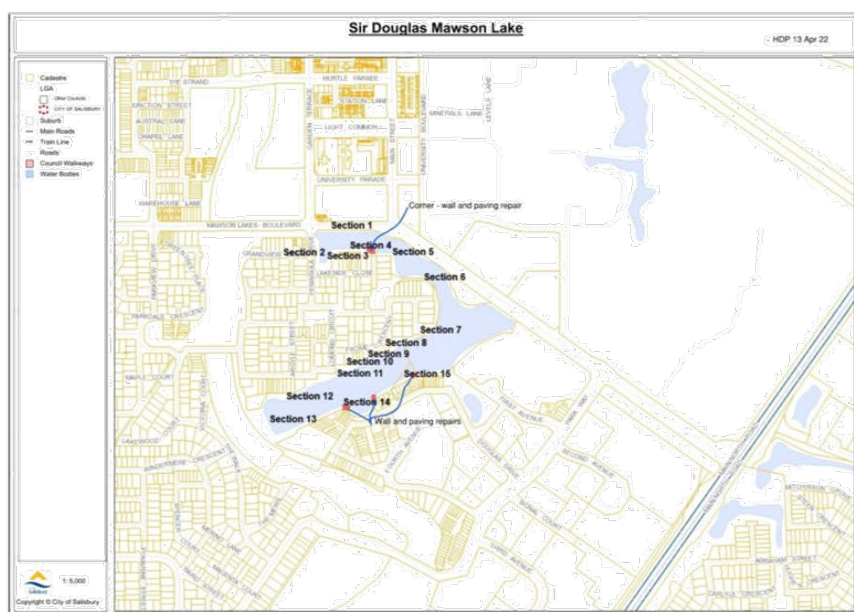
Figure 2- SDML Allsurv Survey Monitoring Sections

- It appears that a full-scale rectification project was never implemented. Instead, localised rock fill treatments were applied to stabilize select sections of the lake edge walls at Sections 12 and 13 identified on Figure 2.

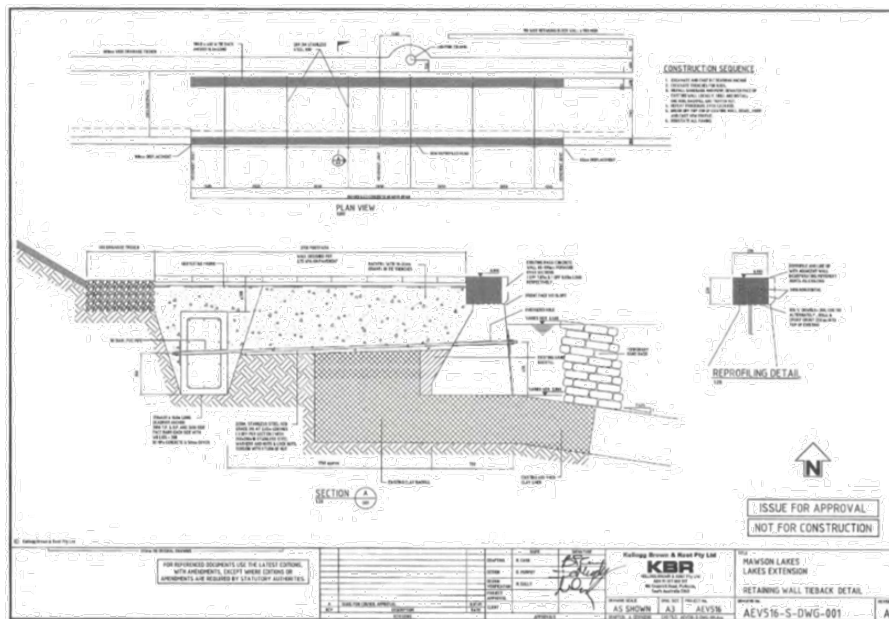
Figure 3- KBR Retaining Wall Tieback Detail (KBR, 2005) – not implemented

- KBR proposed a tieback solution (see Figure 3) around the time of handover of Mawson Lakes to Council for ongoing care and maintenance.
 - WGA investigated sections of failing revetment walls within Stage 2 of SDML. They recommended using 600mm wide x 2000mm long grout-filled plastic bags to fill voids and reinforce walls stability. There were four wall rectification strategies (Type A to D), tailored to different segments of the wall (See Figure 4 and Figure 5 – *WGA Rectification Areas and Treatment Details*).

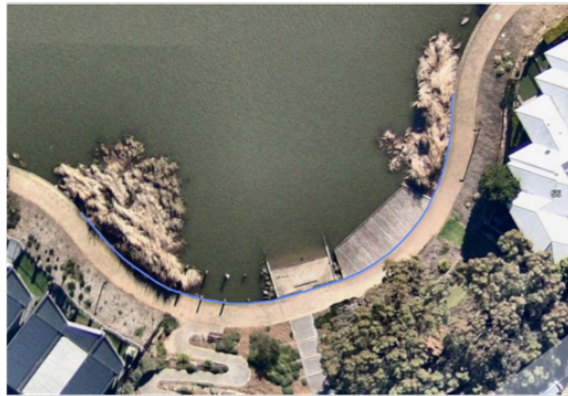
Figure 6- Concave (bay-shaped) Edge Wall

- The lake features edge walls with straight, concave (bay-shaped), and convex (headland-shaped) segments, each of which experiences different stability challenges due to variations in wave energy distribution, hydrodynamic forces, and structural load transfer.
- Concave (bay-shaped) revetment walls benefit from an interlocking arch effect, where lateral soil and water pressures are distributed across the curved segment. This improves the wall's structural stability, reducing the likelihood of localised failures. In addition, concave segments are less exposed to direct wave action as wave energy is partially dissipated due to diffraction and interference.

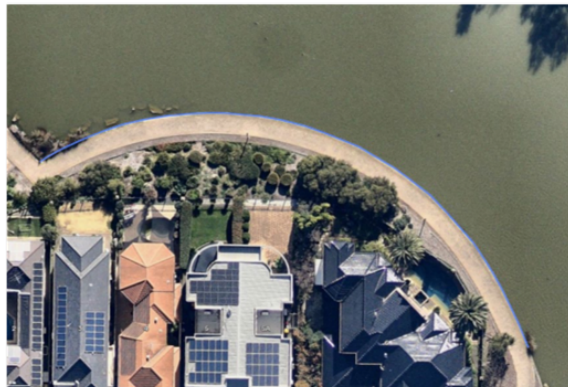
Figure 7- Convex (headland-shaped) Edge Wall

- Convex (headland-shaped) edge walls, by contrast, lack the supportive arching action and thus behave more like independent retaining wall segments. This makes them more vulnerable to outward lateral forces and structural stress concentrations, particularly at the apex. Also, convex segments tend to be more exposed to wave and swell energy, as they protrude into the water and experience concentrated hydrodynamic forces. This increases the risk of scour and structural instability over time. External corners where wall segments are jointed are similarly unstable and tend to pull apart.

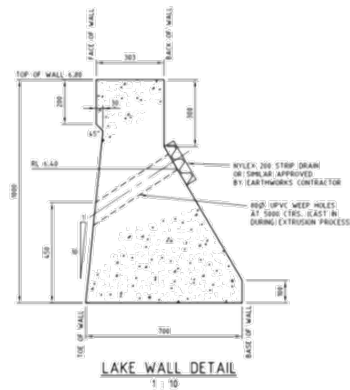
However, a review of the lake wall construction drawings (refer to detail below) indicates that the edge wall includes a Nylex 200 strip drain with 80 mm diameter UPVC weep holes spaced at 5 m intervals. This design allows any water seeping through the wall to be redirected back into the lake, minimising the risk of water loss through the wall structure itself.

In addition, if significant seepage were occurring through the wall, surface heaving or pavement level changes would typically be expected as a visible symptom. In the absence of such signs, it is more likely that any substantial water losses are due to compromise or degradation of the bottom liner, rather than through the wall.
